The Preservationist

Spring 2021

REHABILITATING INTERIORS IN HISTORIC BUILDINGS

Identifying and Preserving Character-defining Elements

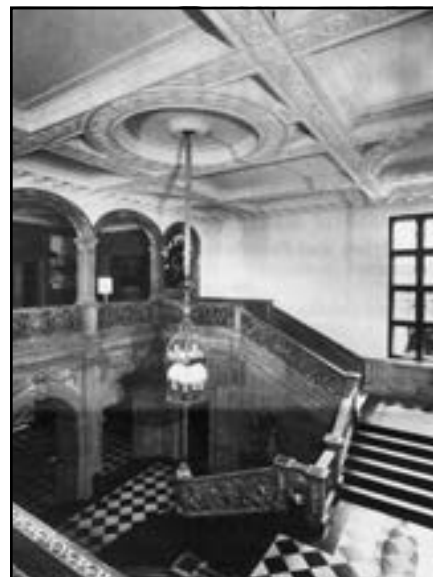
Figure 1. This architect-designed interior reflects early 20th century American taste: the checkerboard tile floor, wood wainscot, coffered ceiling, and open staircase are richly detailed and crafted by hand. Not only are the individual architectural features worthy of preservation, but the planned sequence of spaces—entry hall, stairs, stair landings, and loggia—imparts a grandeur that is characteristic of high style residences of this period. This interior is of Greystone, Los Angeles, California. Photography for HABS By Jack E. Boucher

Figure 5. The interior of a simply detailed worker's house of the 19th century may be as important historically as the richly ornamented interior seen in figure 1. Although the interior of this house has not been properly maintained, the wide baseboards, flat window trim, and four-panel door are characteristic of workers' housing during this period and deserve retention during rehabilitation.

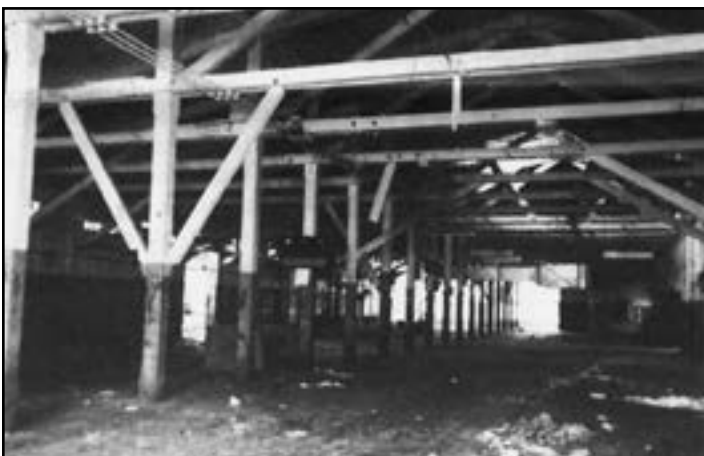
Figure 2. The interiors of mills and industrial buildings frequently are open, unadorned spaces with exposed structural elements. While the new uses to which this space could be put are many retail, residential, or office—the generous floor-to-ceiling height and exposed truss system are important character-defining features and should be retained in the process of rehabilitation.

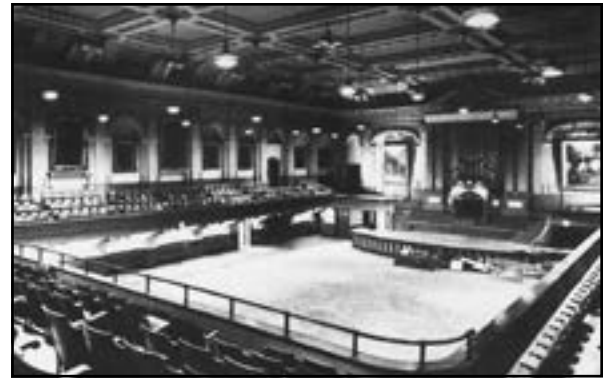
Figure 4. Many institutional buildings possess distinctive spaces or floor plans that are important in conveying the significance of the property. Finding new compatible uses for these buildings and preserving the buildings' historic character can be a difficult, if not impossible, task. One such case is Mechanics Hall in Worcester, Massachusetts, constructed between 1855 and 1857. This grand hall, which occupies the entire third floor of the building, could not be subdivided without destroying the integrity of the space.

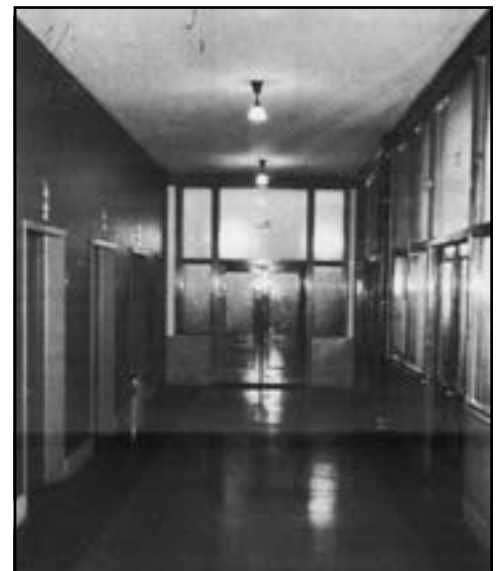
Figure 6. This corridor, located in the historic Monadnock Building in Chicago, has glazed walls, oak trim, and marble wainscoting, and is typical of those found in late 19th and early 20th century office buildings. Despite the simplicity of the features, a careful attention to detail can be noted in the patterned tile floor, bronze mail chute, and door hardware.

The retention of corridors like this one should be a priority in rehabilitation projects involving commercial buildings.

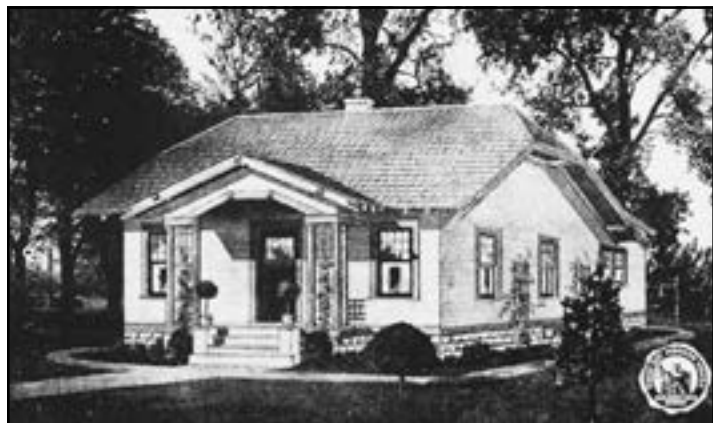
THE RODESSA

The Rodessa was described as "a most attractive little home" which was one of the company's most popular models. Priced at \$1,189, the Rodessa had four rooms and a bath. It was sold between 1919 and 1929.

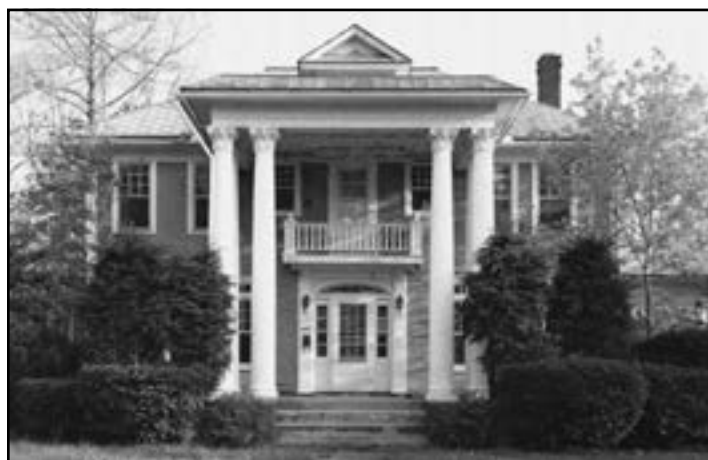
THE MAGNOLIA

**PRIVATE RESIDENCE - 424 19th Street N.W.
Architectural Style: Colonial "Catalogue"**

At one time, most anything could be ordered through the Sears Roebuck Catalogue, even including a house. The "Magnolia," one such Sears "Catalogue" house, could be purchased for only \$5,140, not including cement, brick, or plaster. The style of this particular house was adapted from Henry Wadsworth Longfellow's home in Cambridge, Massachusetts. The "top of the line" model in the 1918 Sears catalogue, only a few "Magnolias" were sold and the Ridgewood home is the only one known to still be in use as a private residence.

The entire house arrived on a pre-arranged schedule, pre-cut and disassembled in many assorted packages. Clarence R. Swallow, contractor of the job, supervised a two-man crew in putting the house together, which he compared to a "giant jig-saw puzzle." Many years later, he recalled that although top-quality materials were used, "sometimes it took as long to find the right piece as it would have taken to cut it." Tall Corinthian columns, three on each corner of the portico, support a cornice that extends around the entire building. A small pedimented dormer sits atop the flat portico roof, which once carried a balustrade. The front door boasts a fan-light and side lights, and pilasters on each side support a small balcony above. While the exterior has been modified somewhat, the basic structure is easily recognizable from the illustration in the 1918 Modern Homes catalogue.
